## PIPELINE INVESTIGATION REPORT

P99H0021

### CRUDE OIL PIPELINE RUPTURE

ENBRIDGE PIPELINES INC.

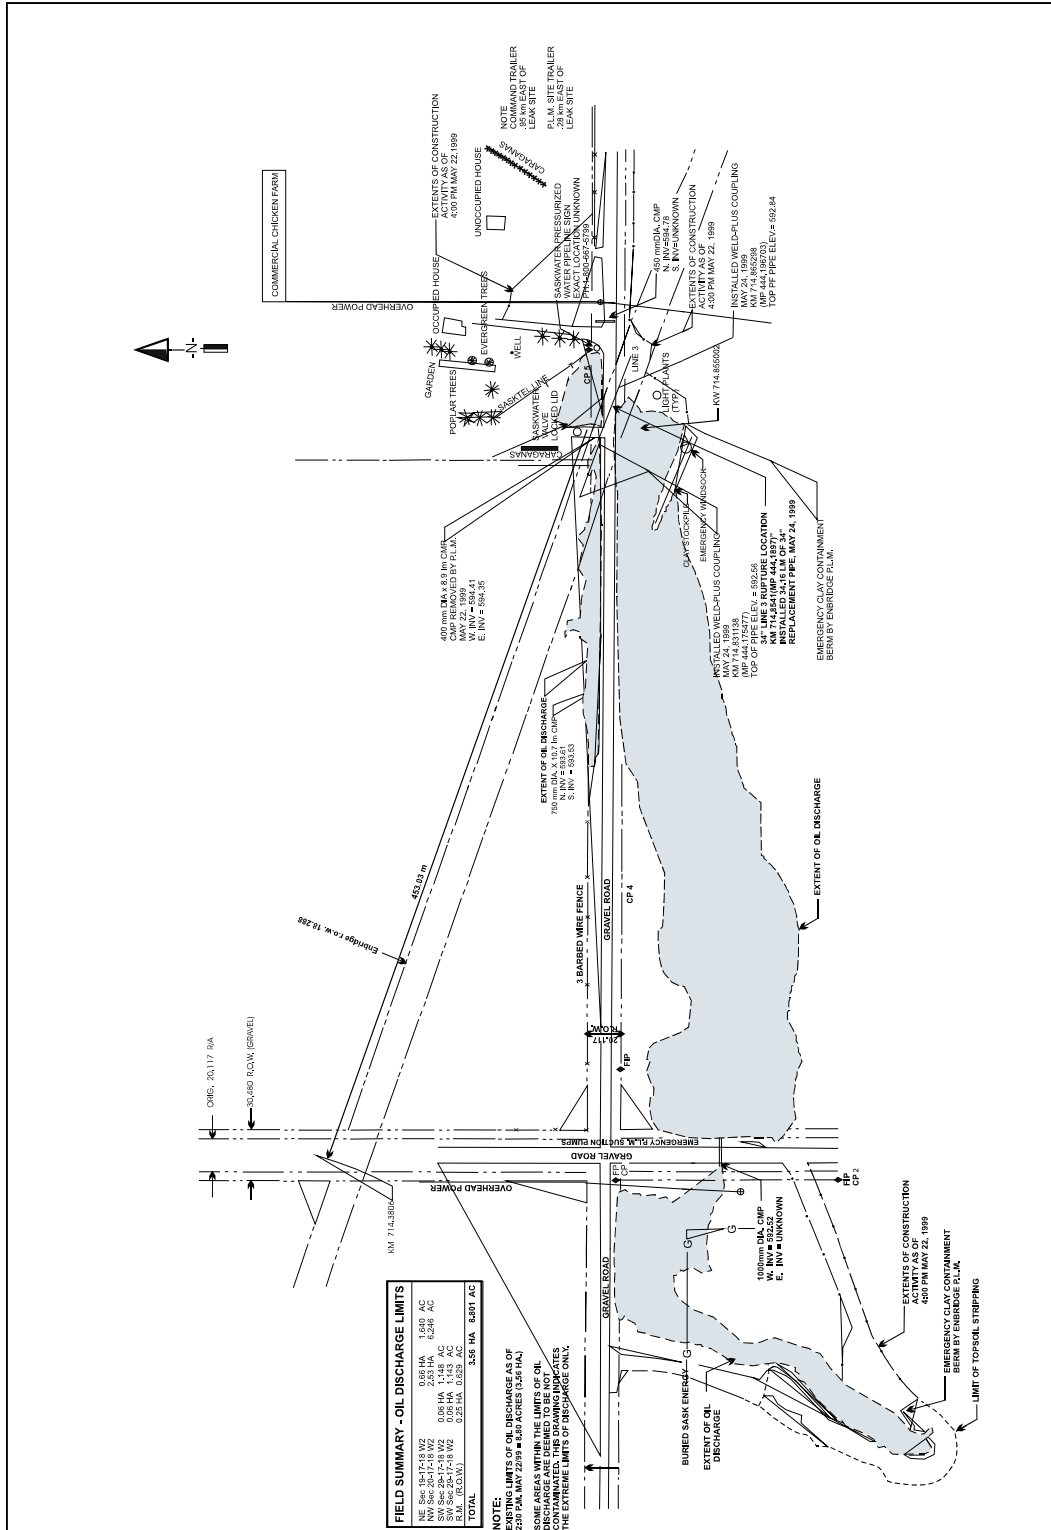
# Appendix A—Site Plan of the Occurrence Site

The occurrence site was located within a road allowance, with landowners on either side. Enbridge's initial priority response was directed towards affected landowners, local emergency first responders, various regulatory agencies and the containment of the released product. Beginning at 2136 mountain standard time (MST)<sup>1</sup> on 20 May 1999, until 0130, 21 May 1999, Enbridge field personnel contacted 15 landowners and evacuated two residences pending the clean-up of spilt crude oil. Since the air was rich in hydrocarbon vapours which could have been ignited with the passage of a vehicle, this increased the urgency for Enbridge's field personnel and local first responders to secure and isolate the occurrence site from the general public. Once the occurrence site was secured, Enbridge's field personnel could then begin the task of contacting, and when required, evacuating local residents until such time as the area was declared safe (see Appendix A for a site plan of the occurrence site).
